JSC-13045

# **Space Shuttle Orbiter Approach and Landing Test Evaluation Report**

Captive-Active Flight Test Summary

September 1977

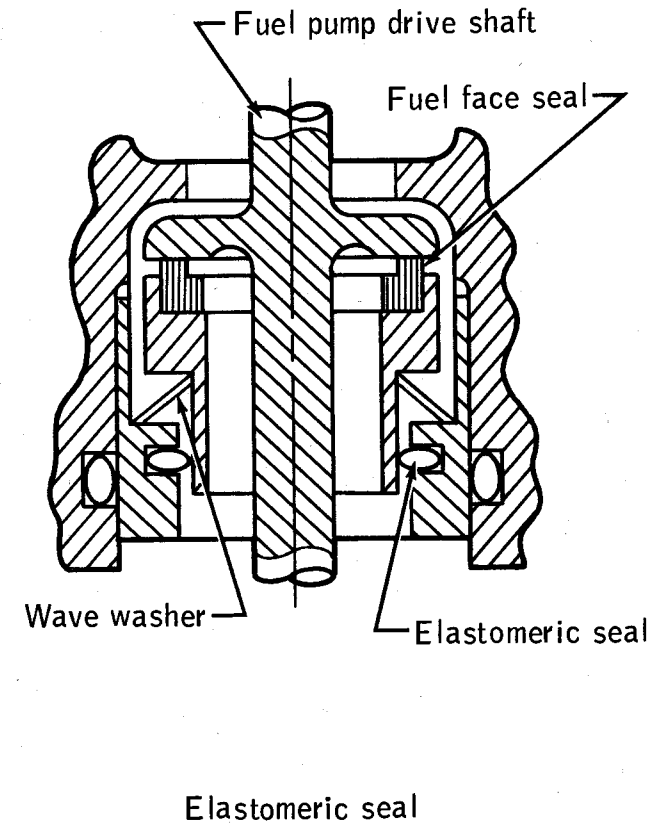
Figure 6-2.- Auxiliary power unit fuel pump seals.

Approximately 18 minutes into the flight, auxiliary power unit 1 was activated as planned. There was an increase in the rate of fuel usage for the unit about 25 minutes after activation. It was determined postflight that failure of the auxiliary power unit 1 fuel pump bellows seal had caused extensive hydrazine leakage.

About 30 to 45 minutes after auxiliary power unit shutdown following the second flight, the pump inlet pressure of unit 1 decayed to 34 psi, indicating fuel (hydrazine) leakage. This indication was supported by an increased rate of unit 1 fuel usage about 25 minutes after activation. Postflight inspection revealed that there had been excessive leakage from the auxiliary power unit 1 fuel cavity drain. This anomaly is discussed in paragraph 6.4.
